HORIZONTAL CAVITY TRAYS OVER HORIZONTAL ROOF ABUTMENTS

This article is brought about in order to refresh our knowledge on a simple, yet vitally important, element of general building, in relation to horizontal roof abutments.

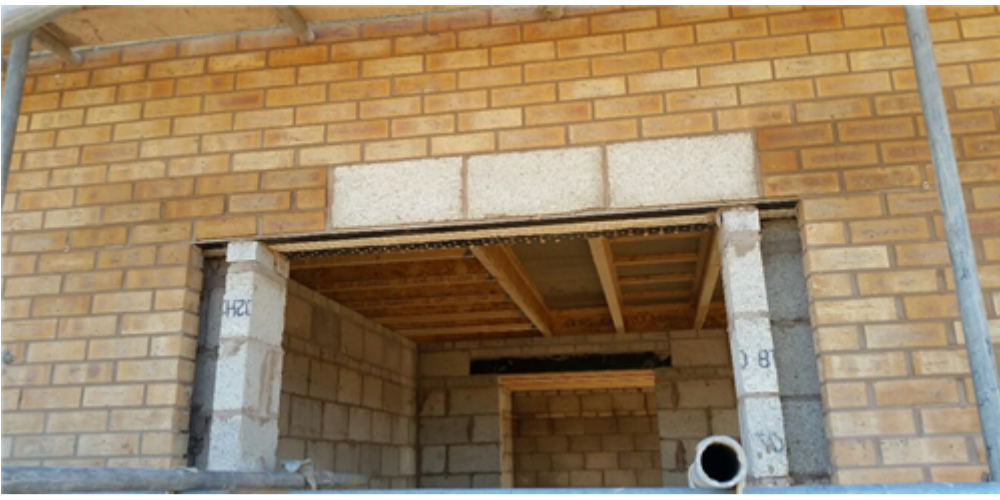
The image below shows an opening which is to receive a GRP flat roof canopy, where you will note the horizontal cavity tray has been lost, by fully pointing up the bed joint the tray sits in. When this occurs most commonly the bed joint is then ground out, using a mechanical grinder to remove the mortar and provide an opening for the cover flashing to dress into the bed joint.

In order to achieve this correct linking the cavity tray must be bedded on a thin bed of mortar, which is then raked out prior to the mortar curing, this is all in order to allow the cover flashing to be installed correctly underneath the cavity tray.

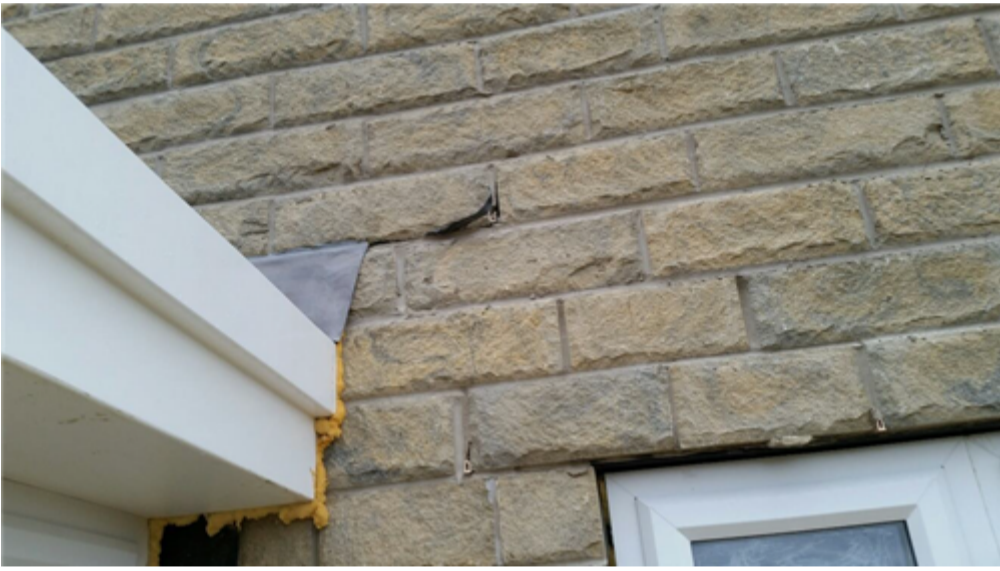
The following photo shows a similar GRP flat roof canopy where the bed joint has been ground out using a mechanical grinder and where evidence can be seen of the cavity tray being damaged. It is this physical damage to the cavity tray that we need to prevent and furthermore ensure that the cavity tray and cover flashing are correctly dressed to shed water.
