## CLAIMS LEARNING: BOX GUTTERS

In this article we are looking into a claim relating to ingress of water due to inadequately designed box gutters and substandard workmanship, on a project for which the roof and gutters were replaced during the conversion of a former coach house into a new dwelling.

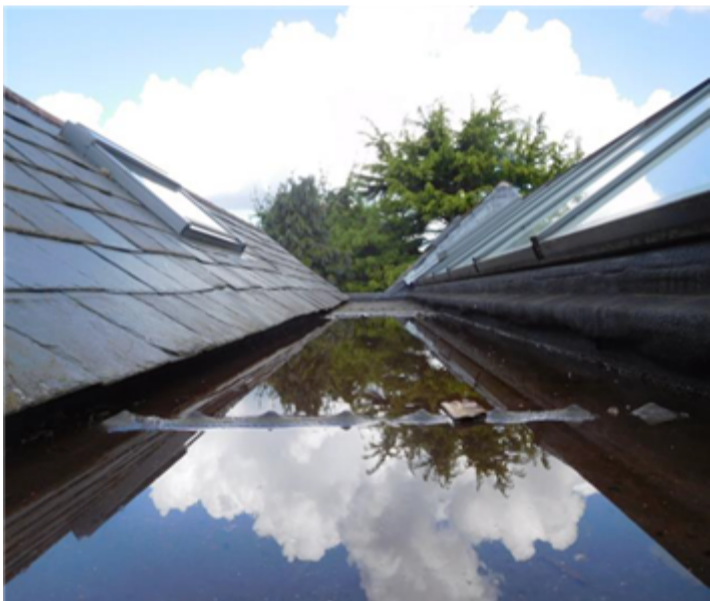
The secret box gutters to each side of the atrium have been constructed with inadequate falls, with virtually no upstand to either side of the gutter. The outlets are inadequate to cope with the volume of water discharging from the adjacent roofs into the secret box gutters and therefore, under periods of heavy rainfall, the gutters flood up over the inadequate upstands and the water tracks into the property. The image to the left shows the lack of fall and ponding of the gutters.

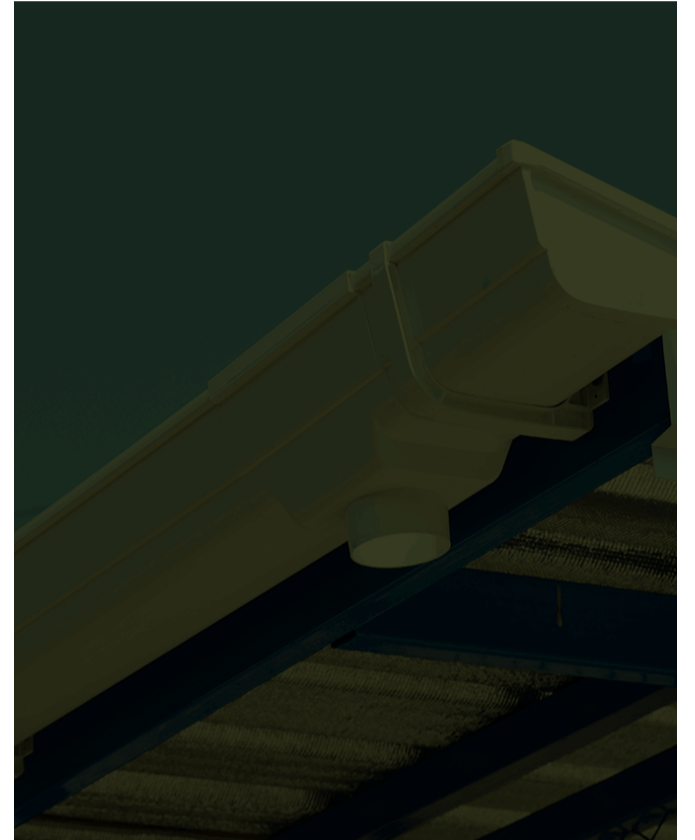
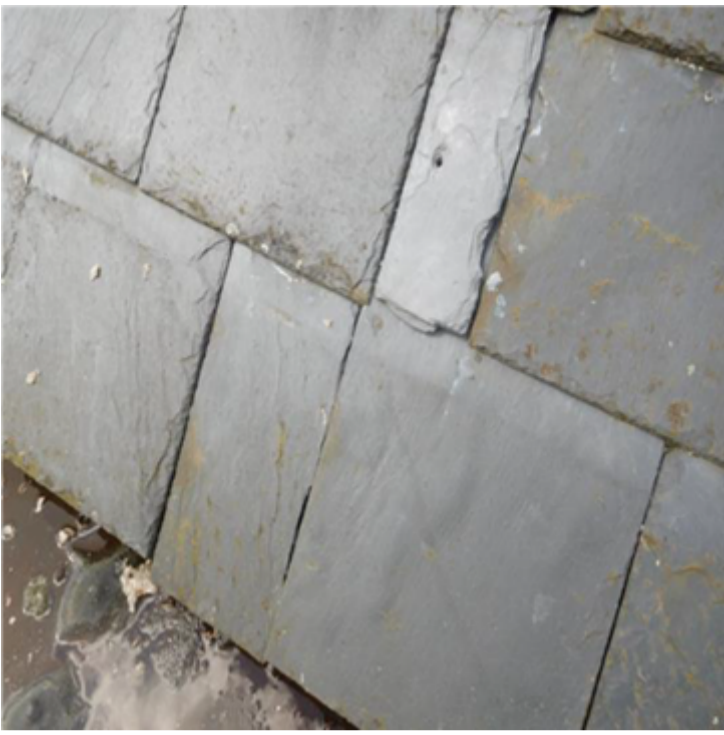
During the investigation into the leaking roof, inspections showed very poor workmanship generally when the roof was recovered. In particular, the standard of workmanship in the vicinity of the secret gutter was extremely poor.

There have been a number of attempts to repair the secret box gutters as can be seen by this image, but fundamentally the roof needs to be stripped in the vicinity of the secret box gutters and new box gutters constructed with adequate upstands, falls and drainage outlets.

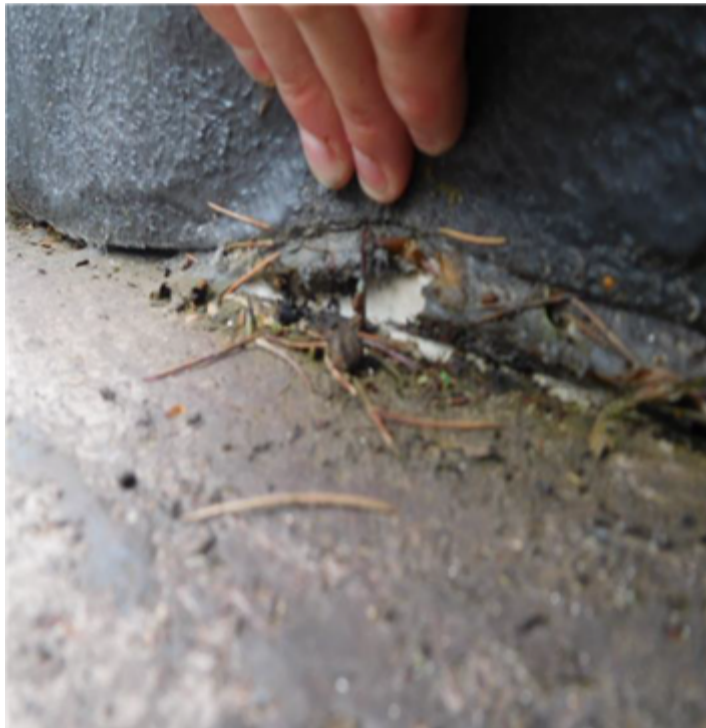
When the original secret box gutter was designed, it should have been regarded as a flat roof interface to pitched roof. The **Premier Guarantee Technical Manual 7.10.9.1:** Figure 7 shows a typical detail. This would have given a minimum 150mm upstand to the box gutter.
