HORIZONTAL CAVITY TRAYS OVER HORIZONTAL ROOF ABUTMENTS

This article is brought about in order to refresh our knowledge on a simple, yet vitally important, element of general building, in relation to horizontal roof abutments.

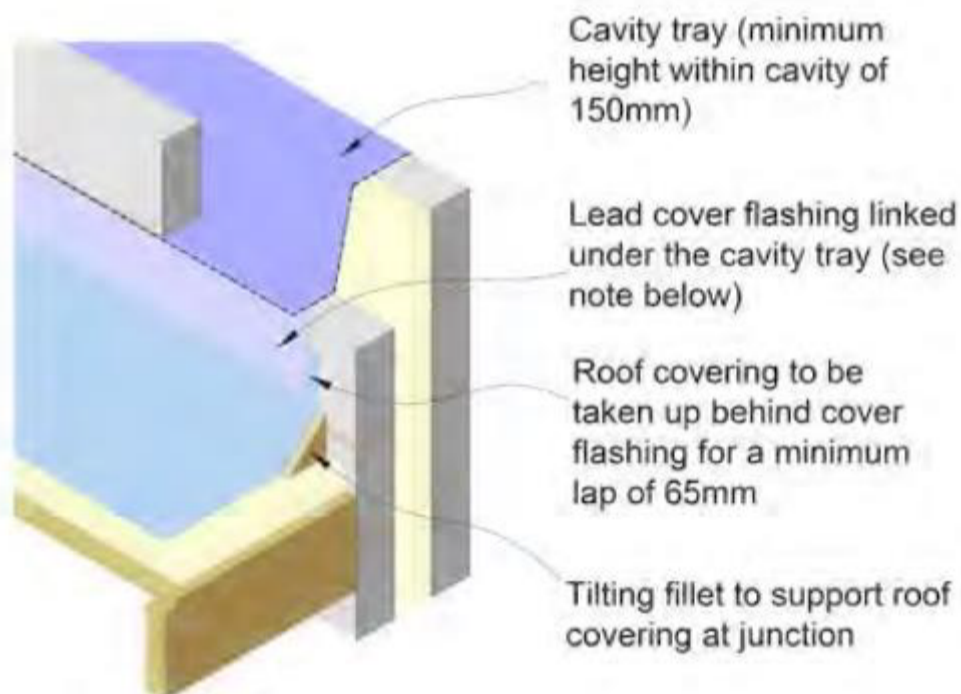
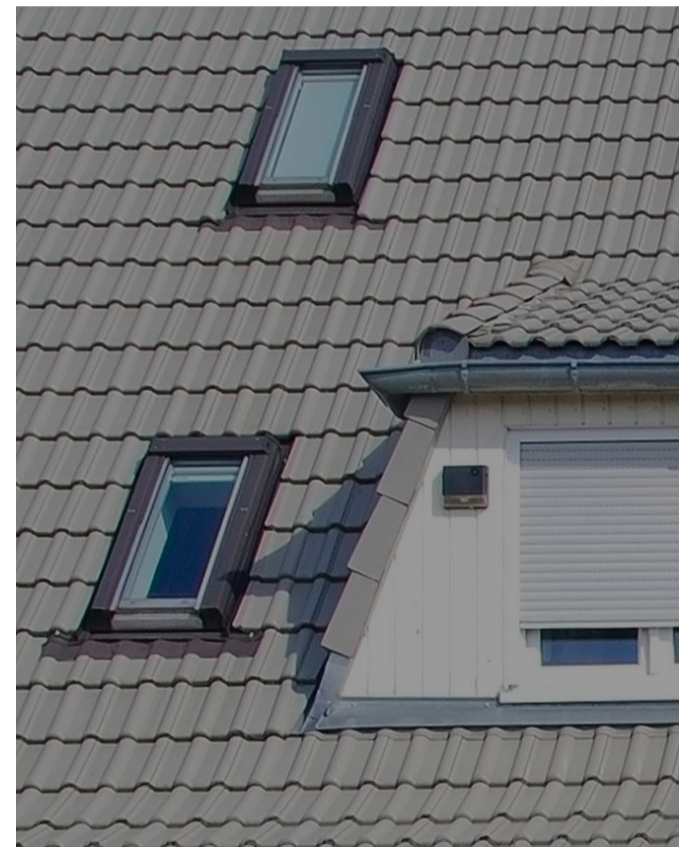
Within Chapter 7 of our Technical Manual the detail below can be found showing a horizontal roof abutment.

One of the critical details here is the correct linking of the cavity tray with the cover flashing, in that the cover flashing must sit directly underneath the cavity tray.

In order to achieve this correct linking the cavity tray must be bedded on a thin bed of mortar, which is then raked out prior to the mortar curing, this is all in order to allow the cover flashing to be installed correctly underneath the cavity tray.
